Poor Fabrication of Stop Log Caused Fly Ash Leak, PPL Investigation Finds

An in-depth evaluation by a PPL team conducting a root-cause analysis of the fly ash leak from Basin #4 at the Martins Creek power plant has determined that faulty fabrication of a wooden stop log led to its failure 16 years after it was installed.

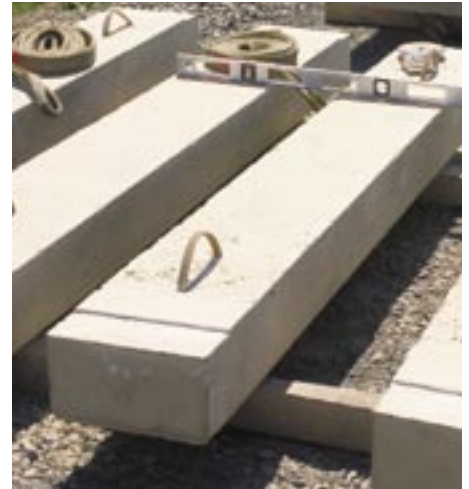
The wooden stop logs have been replaced by these steel-reinforced concrete logs.

The report from PPL's team clearly shows that this incident was inconsistent with PPL's high operational standards. We're already pursuing many of its recommendations. Basin #4 has been upgraded – the stop logs have been replaced and steel plates and valves have been added to the discharge system. One other ash basin at a different company facility that has a similar design already has been modified to prevent an uncontrolled release.
