NORMANDEAU ASSOCIATES, INC.

CHARACTERIZATION OF MUSSEL HABITAT UTILIZATION IN THE VICINITY OF THE HOLTWOOD HYDROELECTRIC PROJECT

Normandeau Project No. 20500.001

March 2006

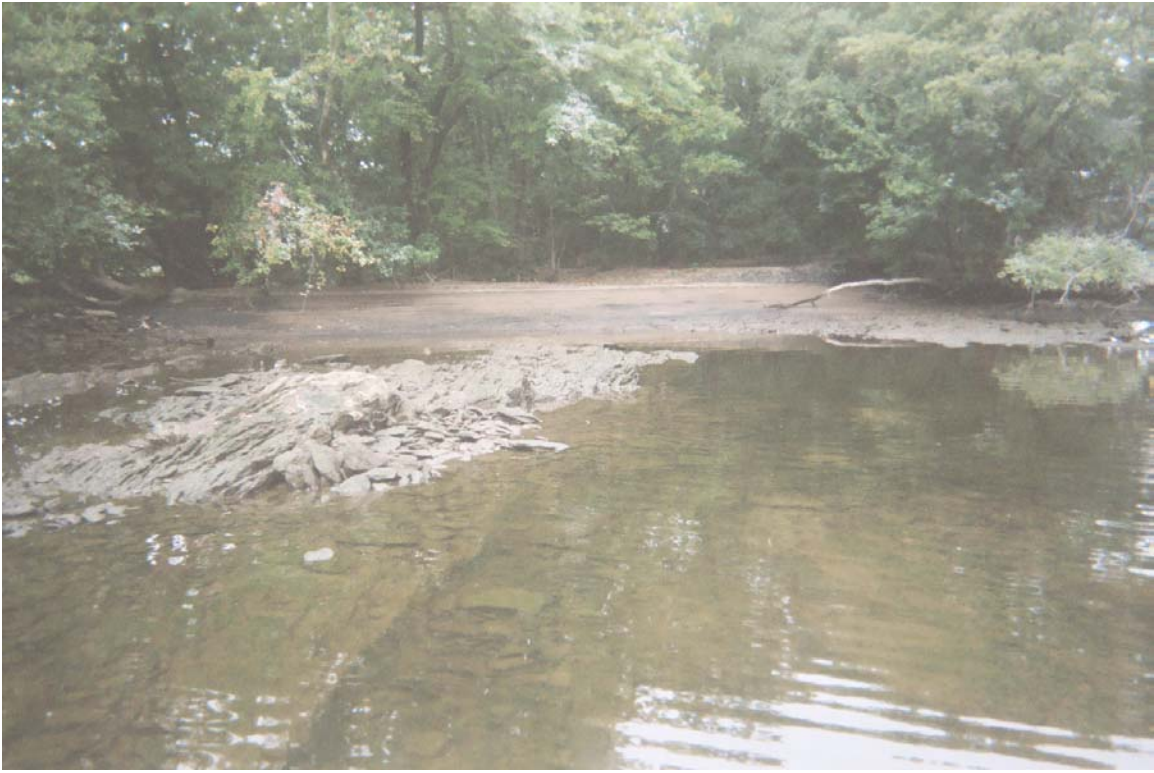
Figure 1. Island shoreline near the Norman Wood Bridge on 14 September 2005.

Survey in this area was initiated by boat travel along the river's east shoreline searching for suitable substrate, starting approximately 0.5 mile downstream of the Norman Wood Bridge. Most of the river shoreline and that of the nearby islands up to the bridge was observed to be steeply pitched and composed of cobbles, boulders, and much bedrock. The exception was an area located along an island shoreline 0.25 mile downstream of the bridge (Figure 1). This location, sheltered from the relatively fast-flowing offshore tailrace water by an island located immediately upstream, is approximately 5,000 square feet in area. Here, the substrate consists of flat fractured bedrock and cobbles and small boulders in a matrix of sand and gravel.

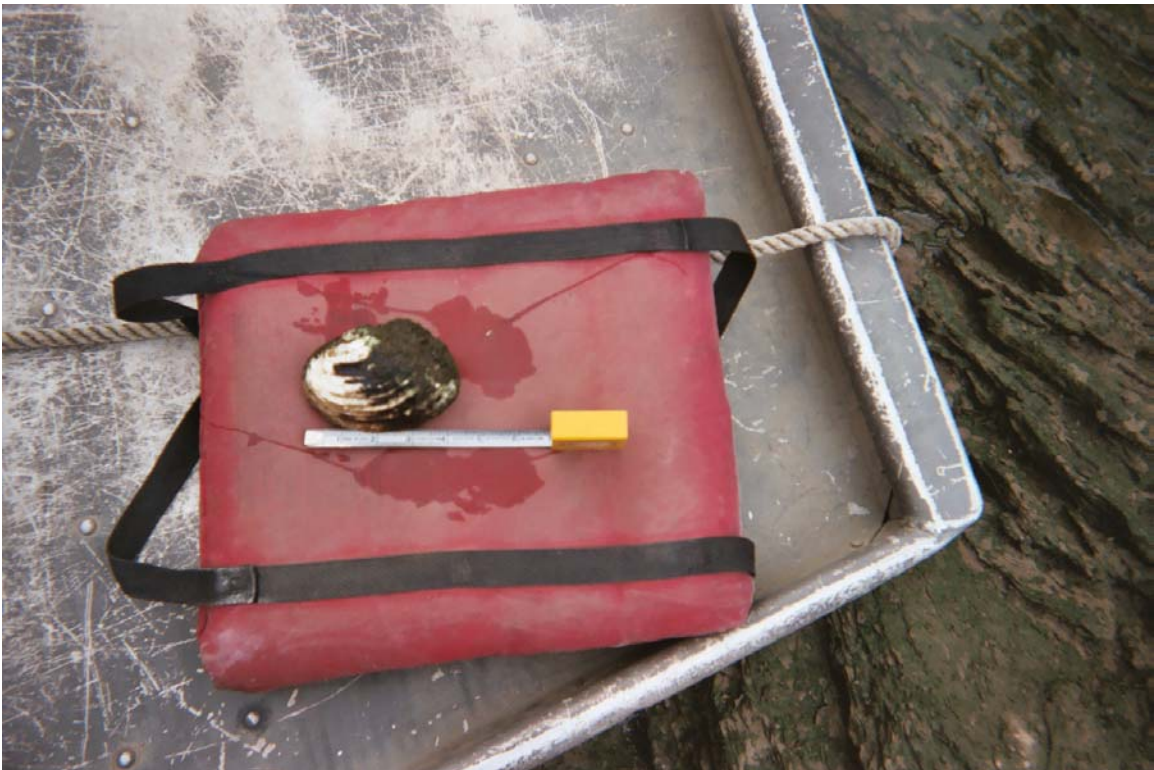
Figure 2. Yellow lamp mussel encountered along island shoreline near the Norman Wood Bridge on 14 September 2005.

The only live mussels identified downstream of Holtwood Dam were discovered partially buried at this location, including one yellow lampmussel (*Lampsilis cariosa*) and five eastern elliptio (*Elliptio complanata*). All were large (the yellow lampmussel 114 millimeters in shell length and the eastern elliptio 127 to 146 millimeters) with eroded shells (Figures 2 and 3). In addition, several spent shells of eastern elliptio and eastern floater were found here. The search for mussels totaled 180 biologist-minutes at this location.

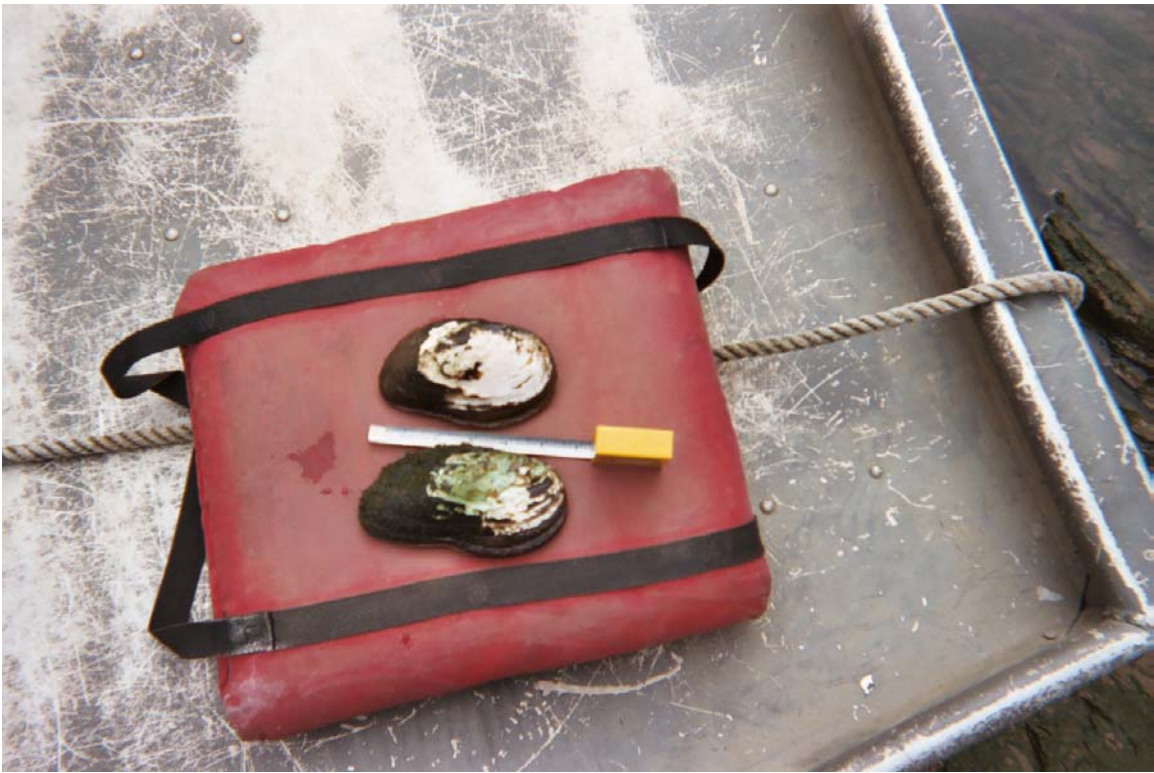
Figure 3. Two of five eastern elliptio encountered along island shoreline near the Norman Wood Bridge on 14 September 2005.

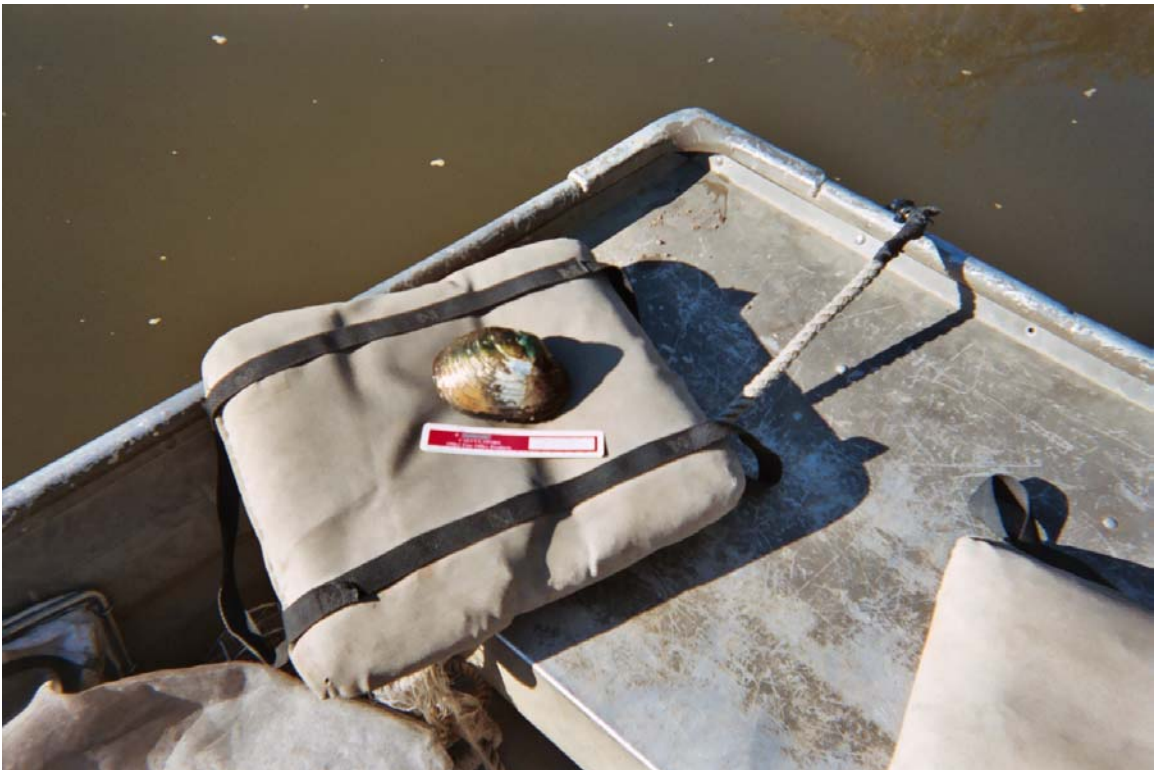
Figure 4. One of three yellow lampmussel encountered at TM16 in Lake Aldred on 14 September 2005.

None of the other species were widely distributed. The eastern elliptio were encountered at only three transects, with 8 individuals identified at TM16. The yellow lampmussel were encountered at only two transects, with 3 individuals identified at TM16 (Figure 4). The other yellow lampmussel was discovered stranded in sand/gravel at TM18, a large bedrock outcrop located at the upper end of Lake Aldred (Figures 5 and 6).

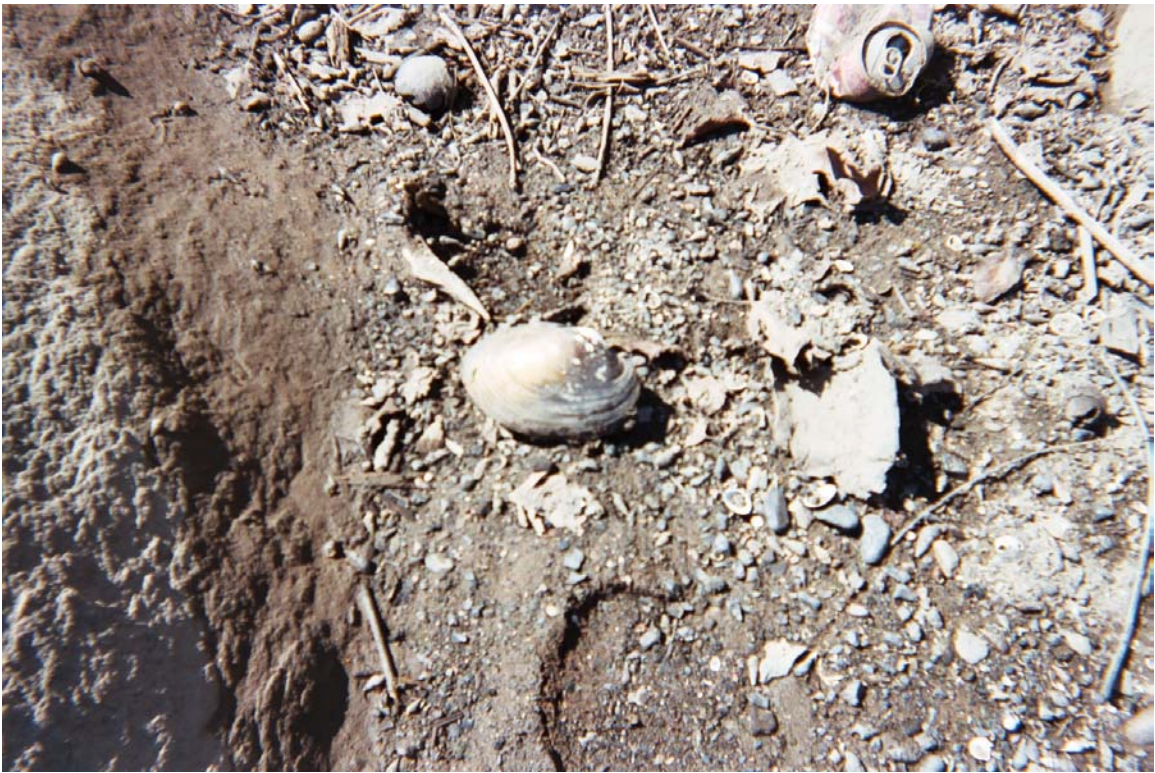
Figure 5. Yellow lampmussel stranded at TM18 in Lake Aldred on 28 September 2005.

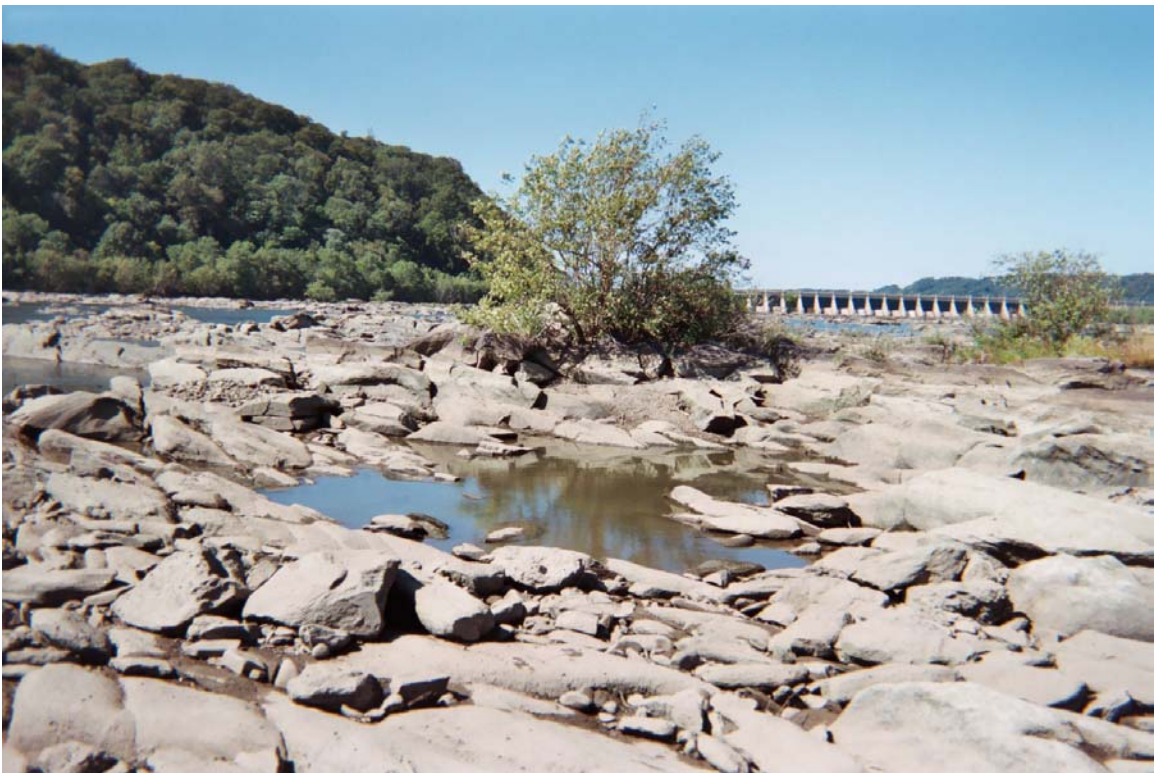
Figure 6. TM18 in Lake Aldred on 28 September 2005.

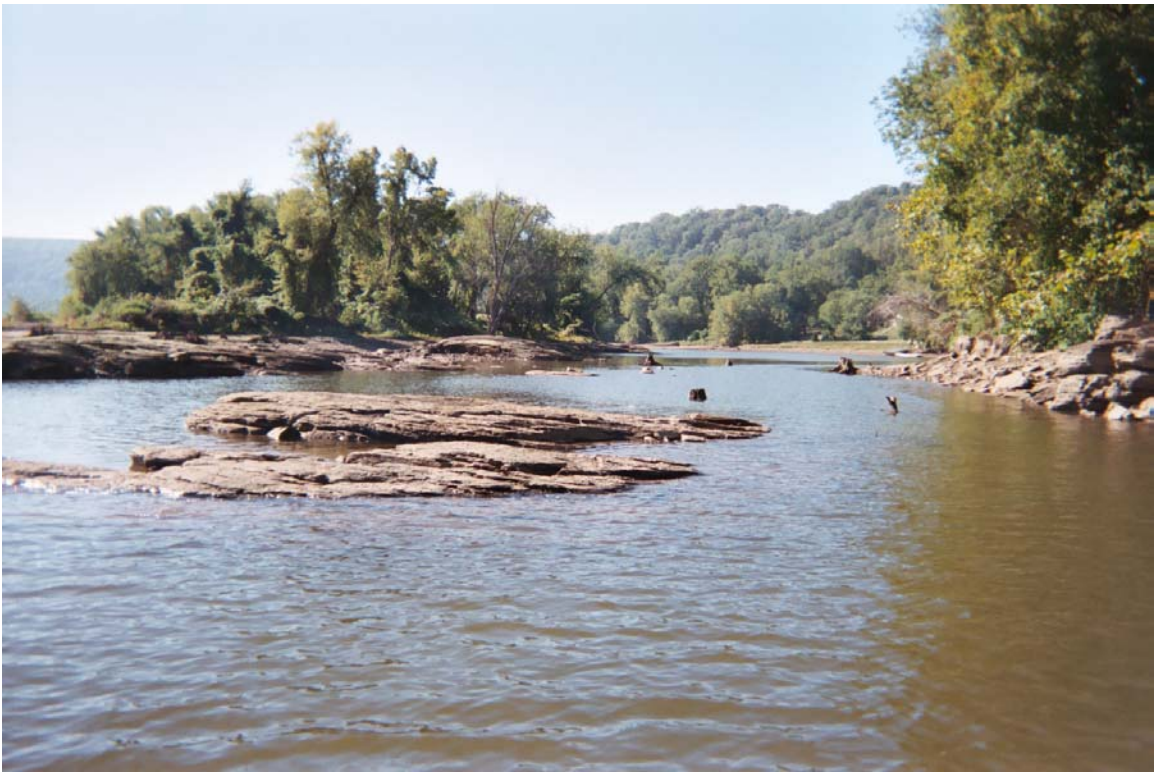
Figure 7. TM16 in Lake Aldred on 28 September 2005.

More mussels (61 individuals) were encountered at TM16 than at any other transect. The largest number of eastern floater (50 individuals) and most of the eastern elliptio (8 individuals) and yellow lampmussel (3 individuals) were identified here. This location was a silt/sand island shoreline containing significant numbers of cobbles and small boulders with much bedrock (Figure 7).

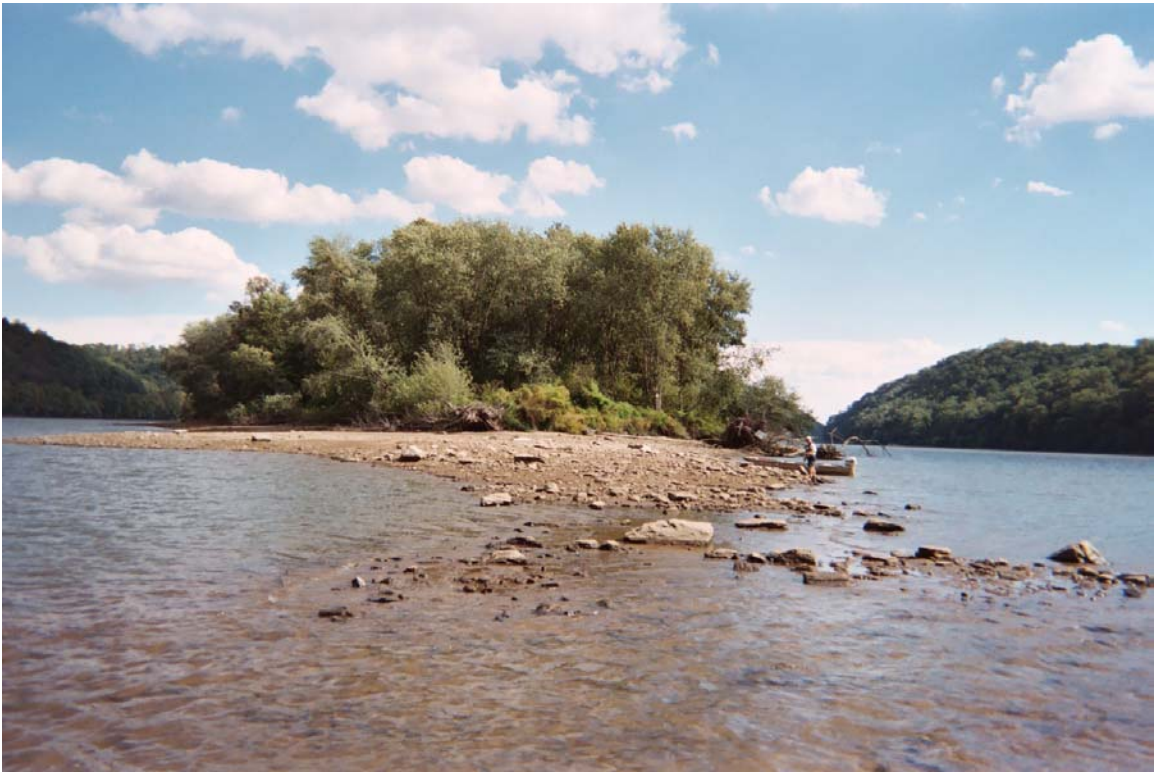
Figure 8. TM20 in Lake Aldred on 29 September 2005.

The only triangle floater was encountered at TM20 on the upstream tip of an island, partially buried in sand among scattered cobbles and boulders (Figure 8). A fairly intensive search (135 biologist-minutes) yielded no other triangle floater and only three eastern floater at this location.
